February 2007

Jackknife Creek  
Stream Restoration Project  
Jackknife Creek Ranch, LLC

Project Overview

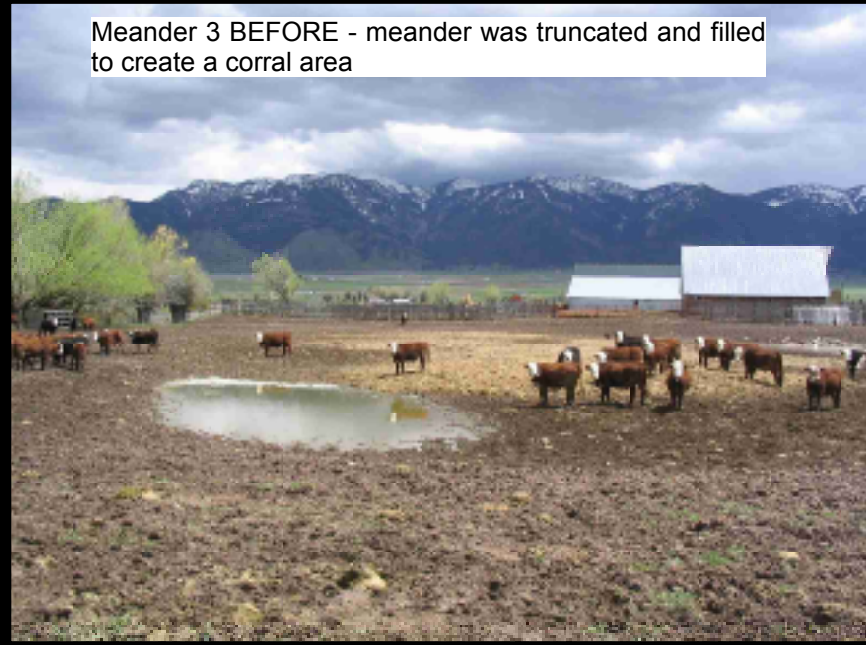
Meander 3 BEFORE - meander was truncated and filled to create a corral area

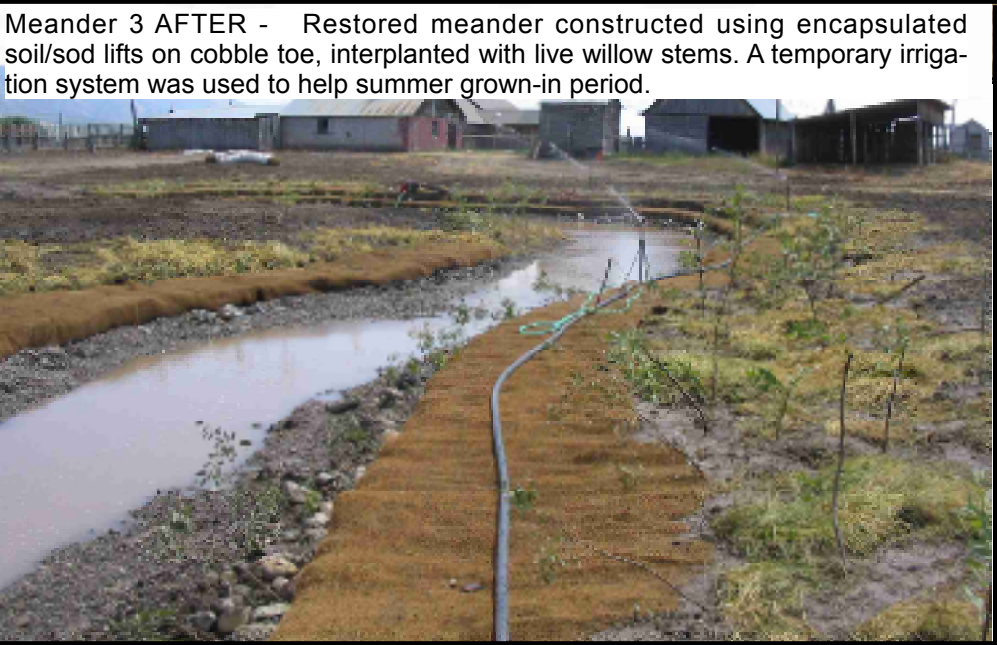
Meander 3 AFTER - Restored meander constructed using encapsulated soil/sod lifts on cobble toe, interplanted with live willow stems. A temporary irrigation system was used to help summer grown-in period.

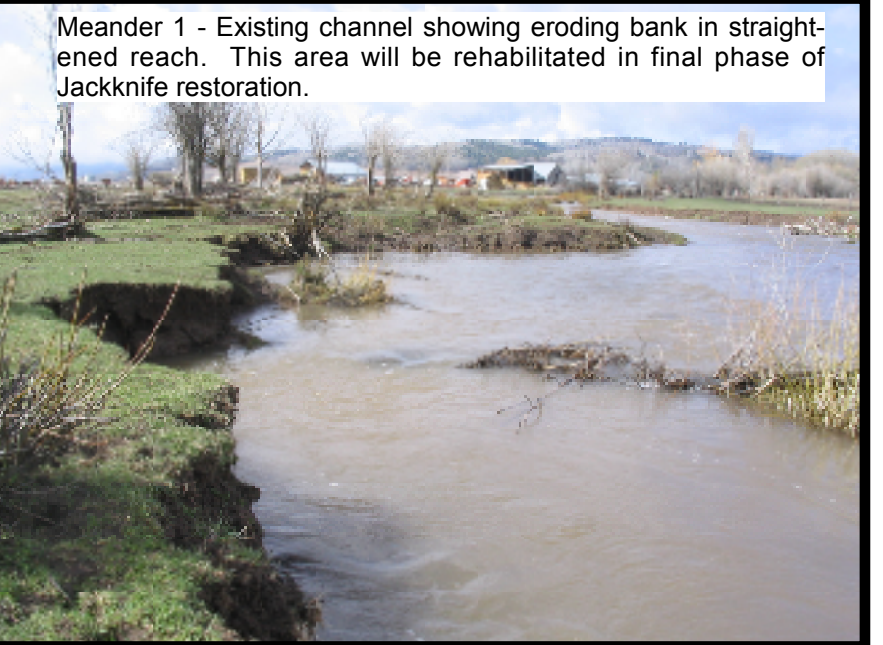
Meander 1 - Existing channel showing eroding bank in straightened reach. This area will be rehabilitated in final phase of Jackknife restoration.
